The Archaeology of Nan Madol and Temwen Island, Pohnpei

**Site Distributions,
Architecture and Early
Agricultural Features,
Pohnpei, Federated States of
Micronesia**

Ayres, Levin, and Seikel 2015

Site Distribution, Architecture, and Early Agricultural Features Madolenihmw, Pohnpei, Federated States of Micronesia

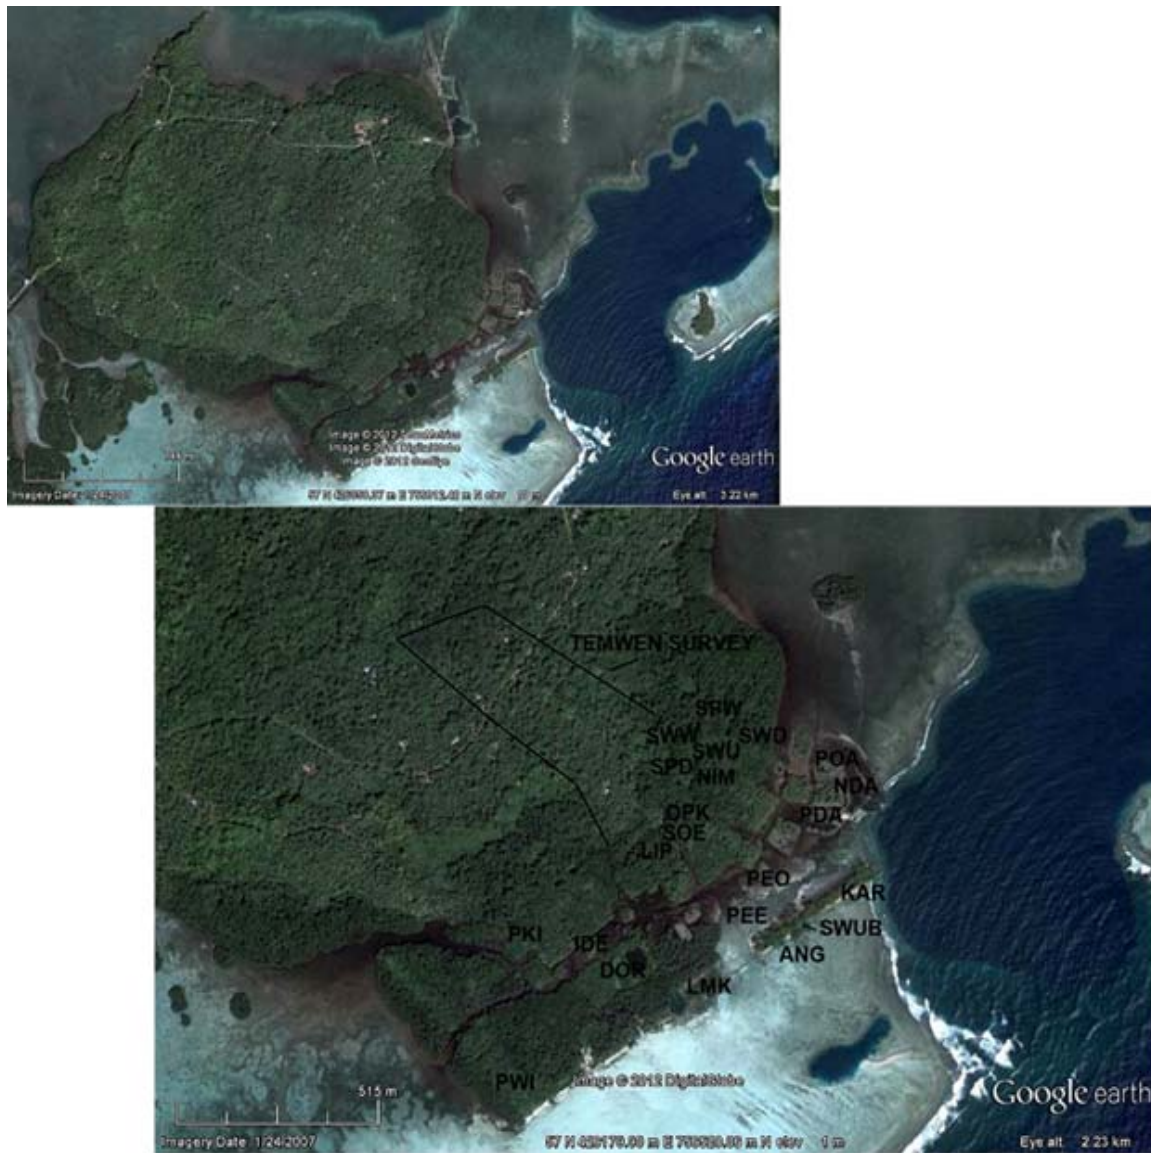
Figure II-1. An aerial map view of the southeastern portion of Temwen Island, Pohnpei, and the Nan Madol islet complex, showing sections of Nan Madol where field studies were conducted. This included research at the seawall islets: parts of Angeir (ANG), Sapwuhtik B (SWUB), Lukepenkarian (LPK); inner Nan Madol islets: Sapwenpwe (SPW), Sapwaka (SWW), Sapwohng (SOE), Sapwudir (SWD), Nihmokemok (NIM), and Likinpei A and B (LIPA,B), as well as observations on Pahn Kadira, Dorong, Pahnwi and Temwen Island. The place names are from Pohnpeian oral traditions and are part of the Pohnpei HPO-University of Oregon site designation system. [base image Google Earth]

A major interest for the present project was in continuing the mapping and architectural analysis of a series of structures and artificial islets in the eastern seawall called Angeir, Sapwuhtik B, and Lukepenkarian. These were the subject of preliminary survey in the 2008 project (see Report 08-1, Ayres, Seikel and Levin n.d./2009), which identified five mortuary structures in addition to ten other architectural features in need of further analysis to enable assessment and conservation. The 2011 fieldwork focused on detailed mapping, architectural analysis, photography, and site conservation status (Figure II-1).

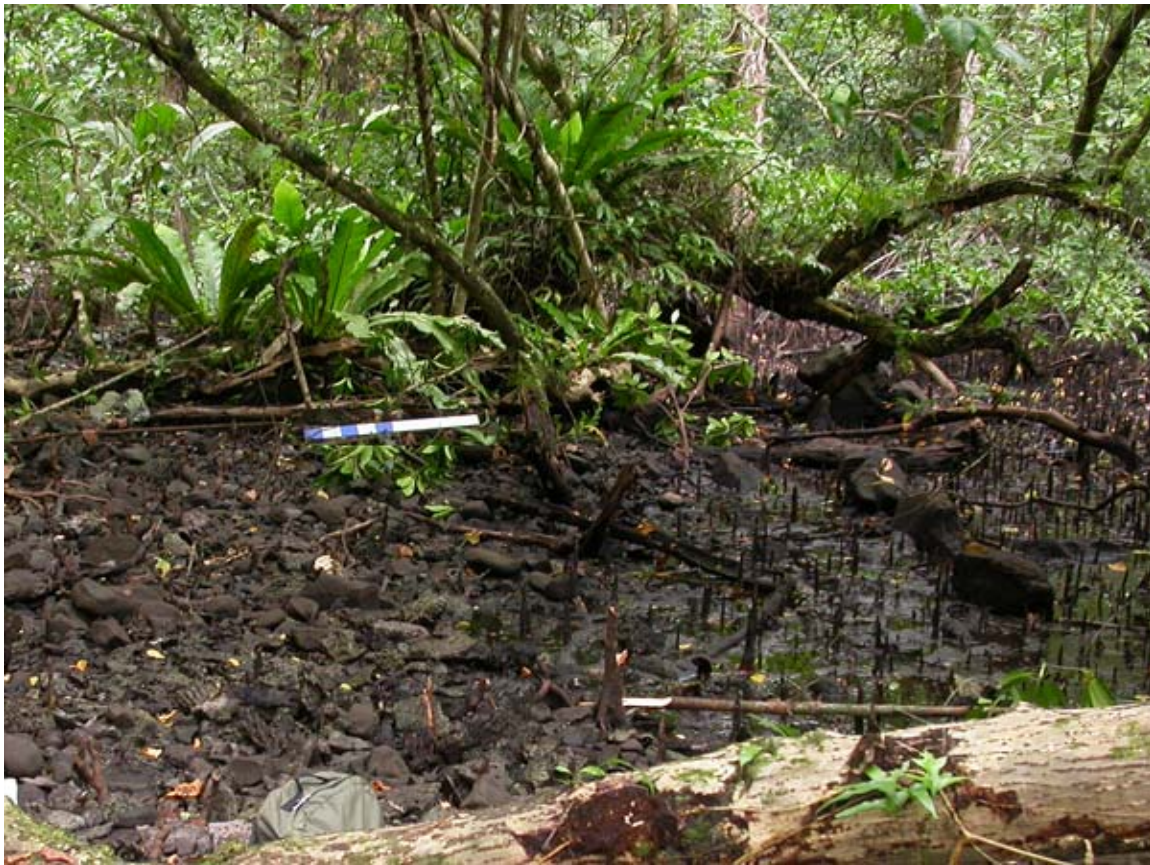
Figure II-2. View of the eroded islet surface of PoC3-1-DPK, Dauahdpeidak Islet, an interior islet within Nan Madol. Low coral-fill structures such as this represent early constructions near the Temwen shore. The alignment of basalt boulders at the right defines the original south wall of the artificial islet. Scale bar is 1 meter. [image: W. Ayres]

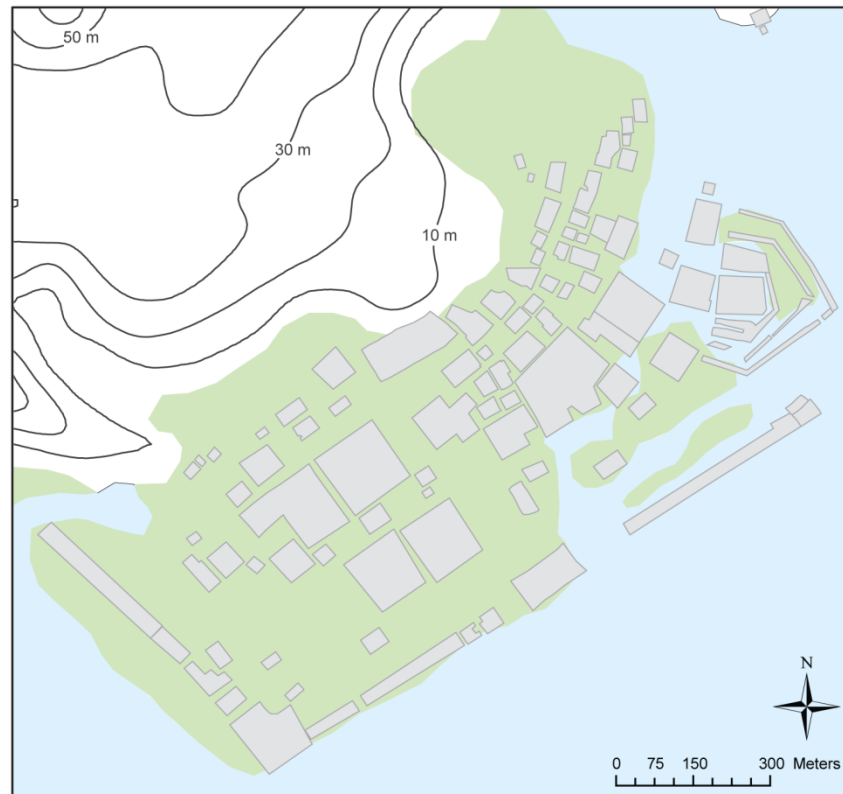
Figure III-2. Base map of Nan Madol (based on original by W. Ayres).

Pohnpei is home to Nan Madol, the largest prehistoric monumental site complex in Micronesia. As an archaeological and environmental site it provides some of the best evidence of how Pohnpei and other Eastern Caroline islands changed environmentally and culturally over a period of nearly 2,000 years. The site of Nan Madol covers approximately eighty hectares on the reef flats adjacent to Temwen Island on the Southeast side of Pohnpei (Figure III-1). It is comprised of over 100 artificial islets constructed primarily over a 1,000-year period (Fig. III-2).

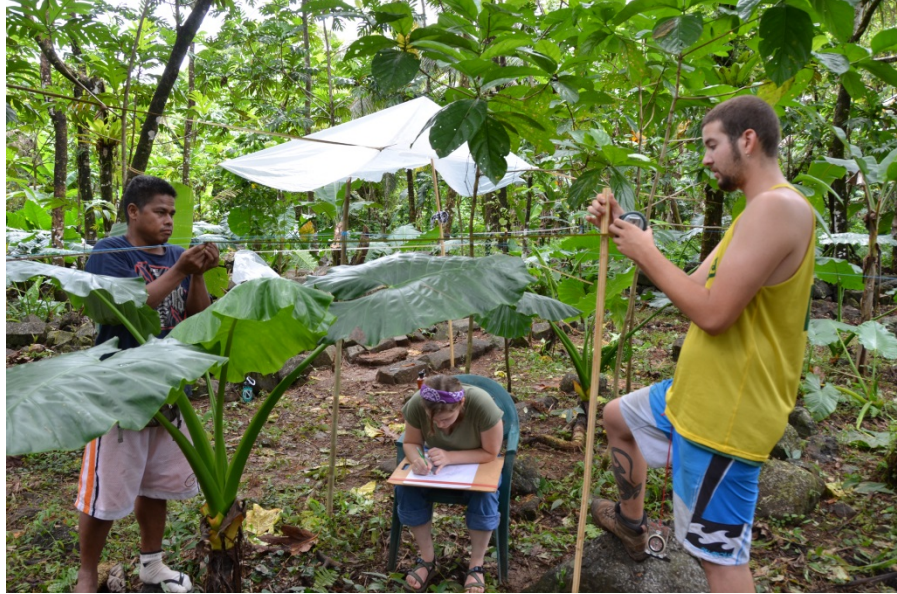
Figure III-3. Mapping in progress at PoC3-5. (Photo by Adam Thompson).

Site PoC3-5 is a *lolong* tomb complex, referred to as “*Peinlohloh*,” consisting of a platform and an enclosing wall (Fig. III-4). The burial platform itself is approximately 4 meters square and is constructed in the header-stretcher style with structural fill comprised primarily of small basalt rubble (Fig. III-5). There are small pieces of coral rubble incorporated in the fill of the platform; the significance and

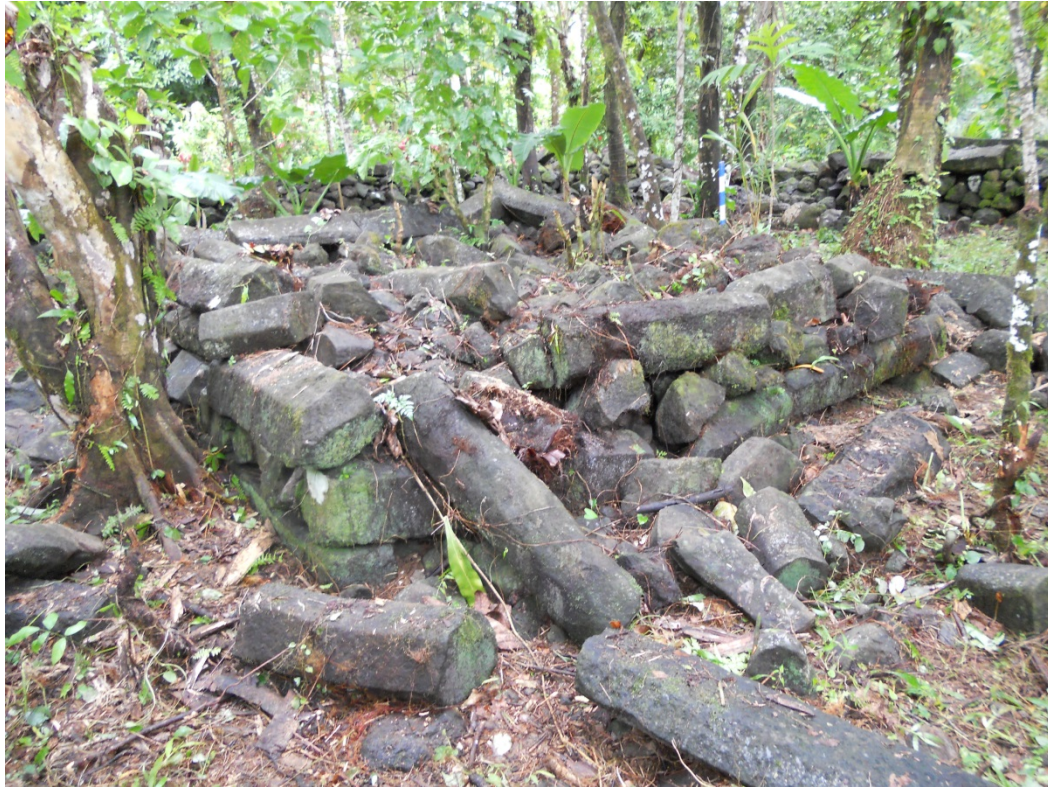
Figure III-5: Site PoC3-5, "Peinlohloh." Shows the burial platform with the enclosing wall in background.

platform is comprised of small to medium sized basalt rubble and looks to be more of a foundation than an actual platform. The 'platform' is approximately 6 meters by 7 meters and rises around 35 centimeters above the surrounding enclosure surface. The enclosing

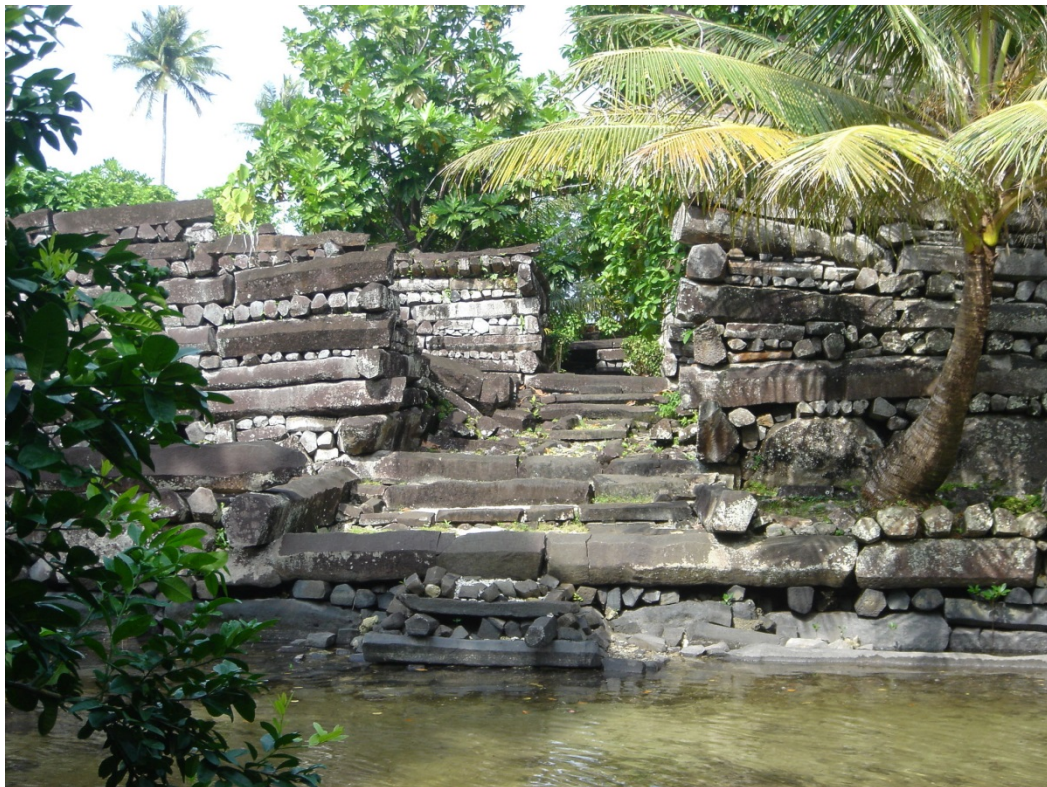
Figure III-6. Nan Douwas islet exemplifies header-stretcher construction at Nan Madol.

With the exception of the burial platform and portions of the Eastern wall at PoC3-5, the Temwen *lolong* were not constructed in the standard header-stretcher style, which is most common at Nan Madol (Fig. III-6). Of the two mortuary structures, only one contained header-stretcher construction features (Feature 1, PoC3-5). Unlike the large *lolong* at Nahndauwas and Karian within Nan Madol, the header-stretcher construction at Feature 1 does not continue through to the interior walls of the structure; it contains an interior wall fill of coral rubble. The architectural variability in the documented mortuary structures in the Nan Madol area suggests that it is likely that there is chronological patterning in architectural conventions and in the amounts of available raw materials for construction.

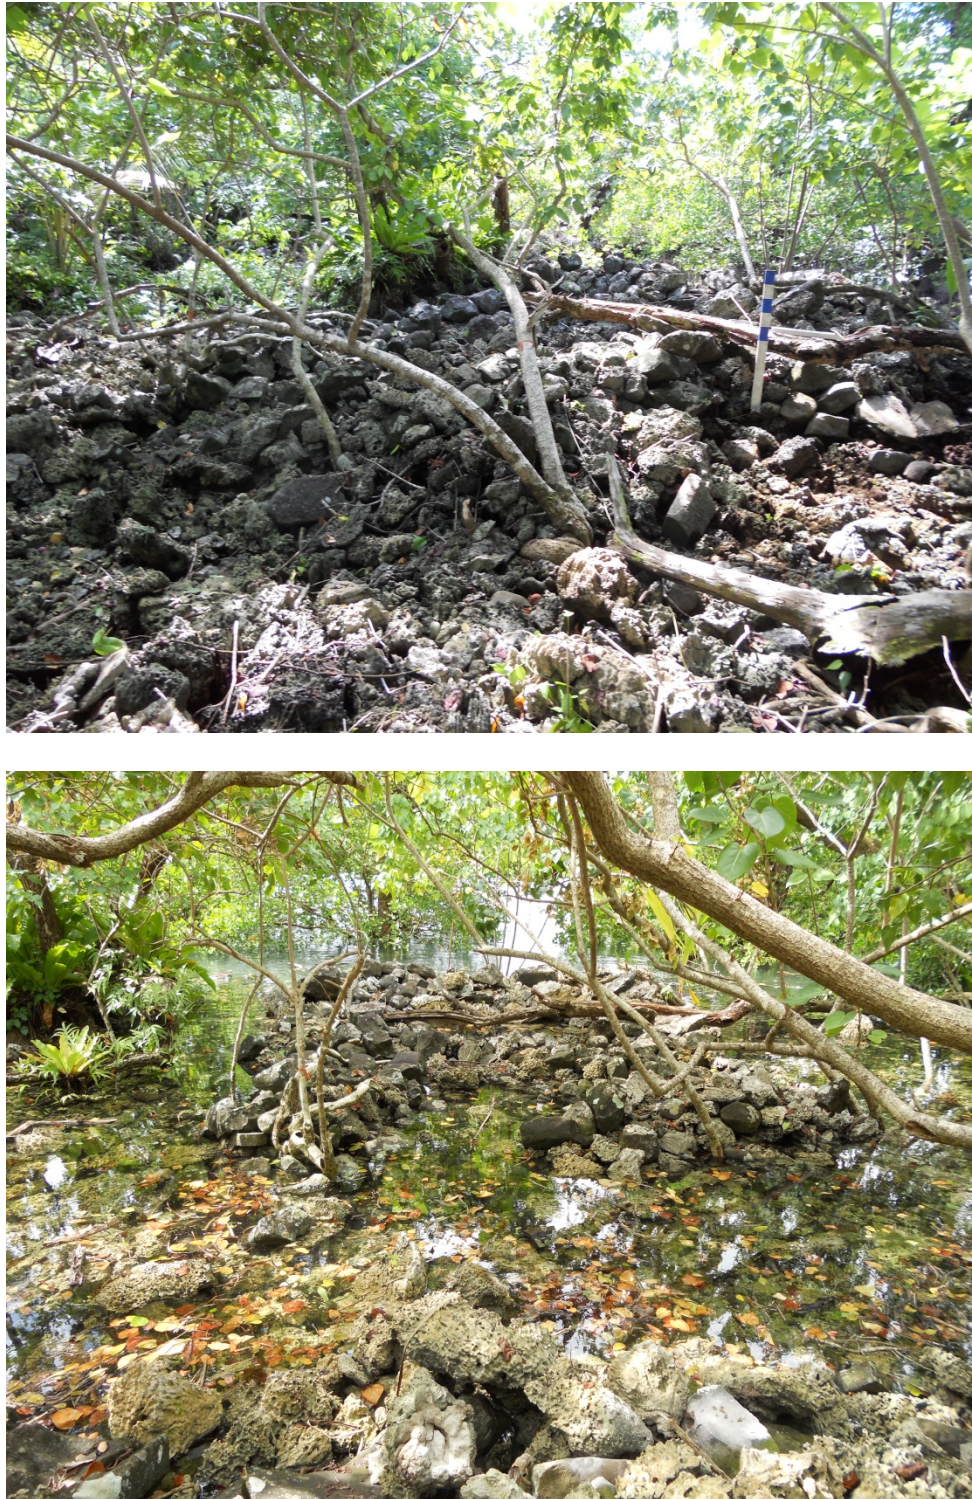
Figure III-9: Site PoC3-1. Feature 2 on Angeir is shown in the showing post-clearing (top) stage and as flooded at high tide (lower photo).

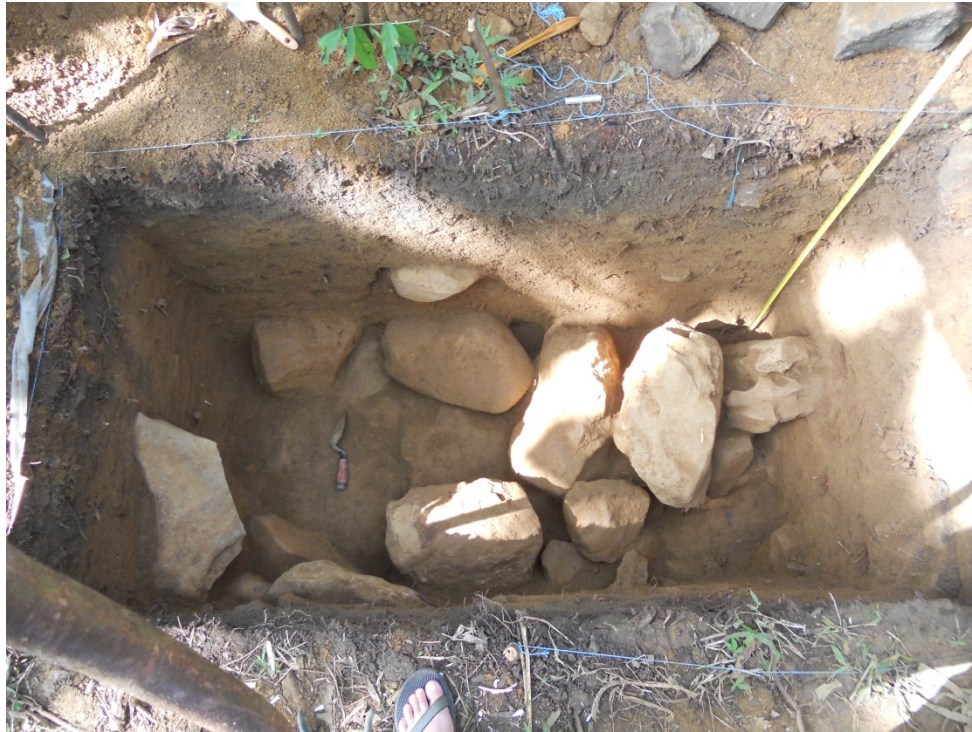
Figure III-10. Site PoC3-5 excavation at depth of 1 meter.

Both excavations produced charcoal, which have provided additional information on when these structures were constructed and used. Six charcoal samples (Fig. III-11) were submitted for AMS dating at the ANU Radiocarbon Laboratory. PoC3-5 securely dates to between AD 1219 and 1385. The earlier dates from this context are sandwiched between the two later dates, which supports the hypothesis that the soil was brought in to level the surface of the enclosure. Site PoC3-8 dates between AD 1300 and 1600. These dates are consistent with results from *Iolong* in Awak and at Nan Madol.

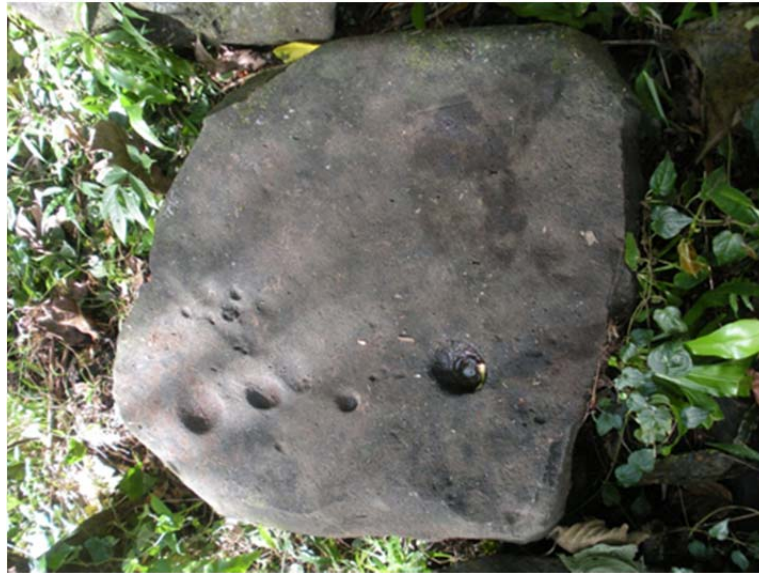
Figure IV-3. Site PoC3-9, Feature 11. *Sakau* stone. [photo M. Levin]

survey. There is a *sakau* stone at the NW corner (Fig. IV-3), and we took surface samples for microremain analysis. A few boulders and cobbles extend out east from this *sakau* stone approximately 2.9m from the east wall of the structure, parallel to the south wall. There are also a few wooden planks present at the southeast end of the structure.

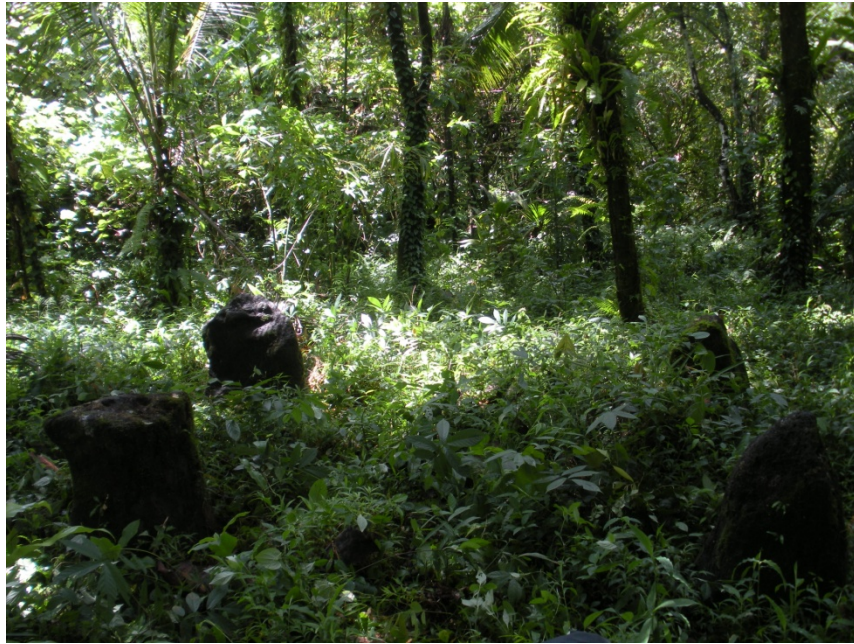
Figure IV-5. PoC3-9, Feature 4.

Feature 4 consists of four basalt rocks, rectangular in shape, planted solidly into the ground. They are placed evenly apart at 2.45-2.50m, and at exactly N-S-E-W corners. The function of this feature is unknown, although it could be a historical feature used as assistance for finding direction.

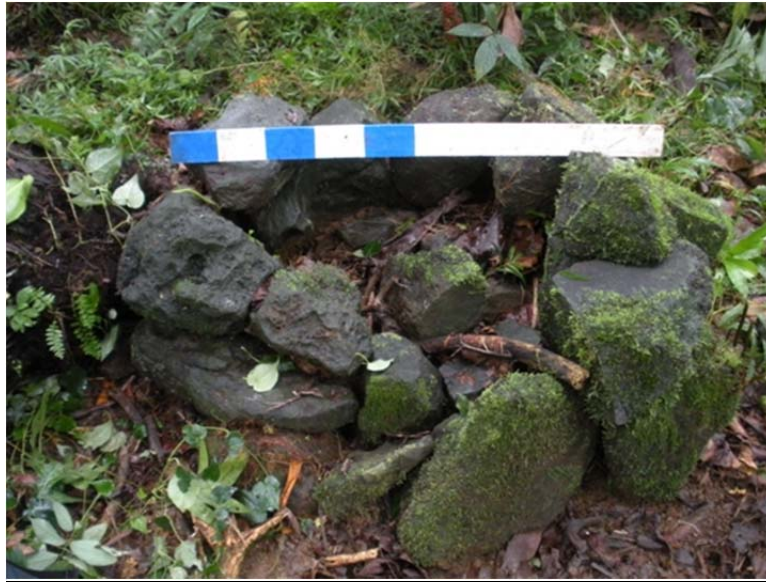
Figure IV-10. Site PoC3-20, Feature 2. A protective enclosure for yam cultivation.

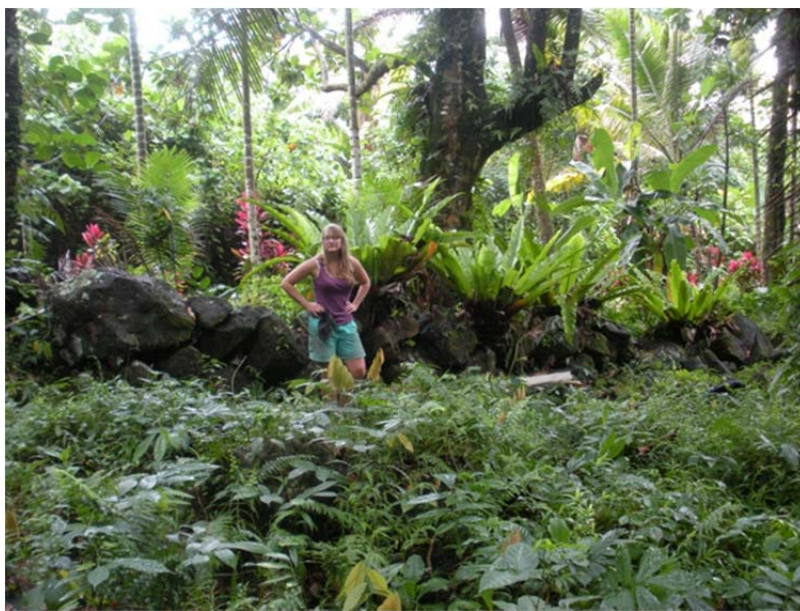
Figure IV-11. Site PoC3-25, Feature 2, with D. Stanszak.

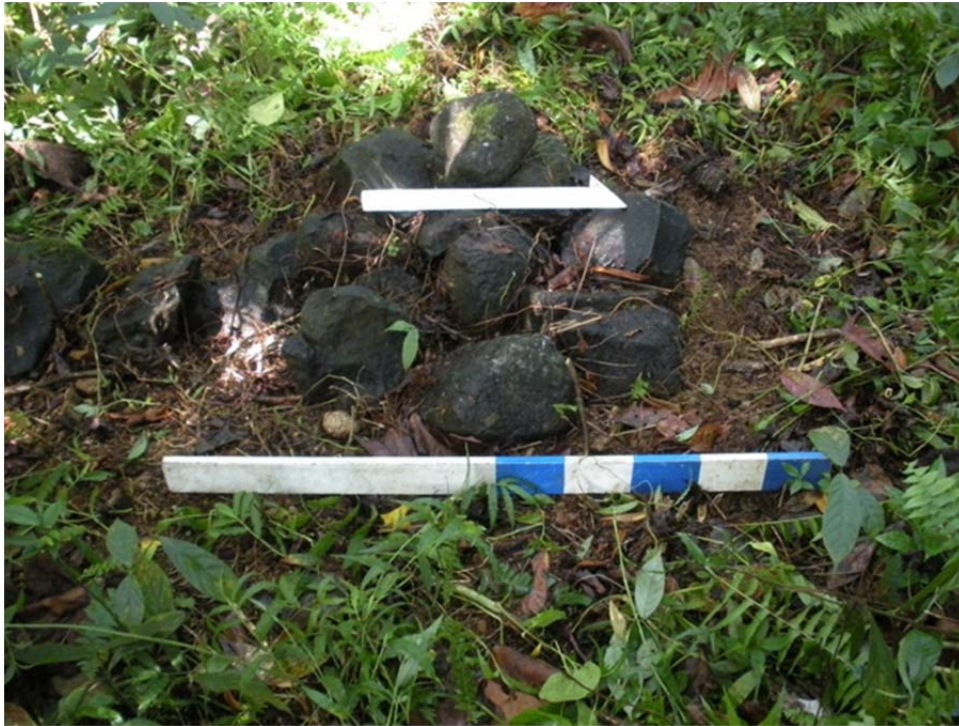
Figure IV-12. Site PoC3-30, Feature 1 [photo: J. Silbanuz].

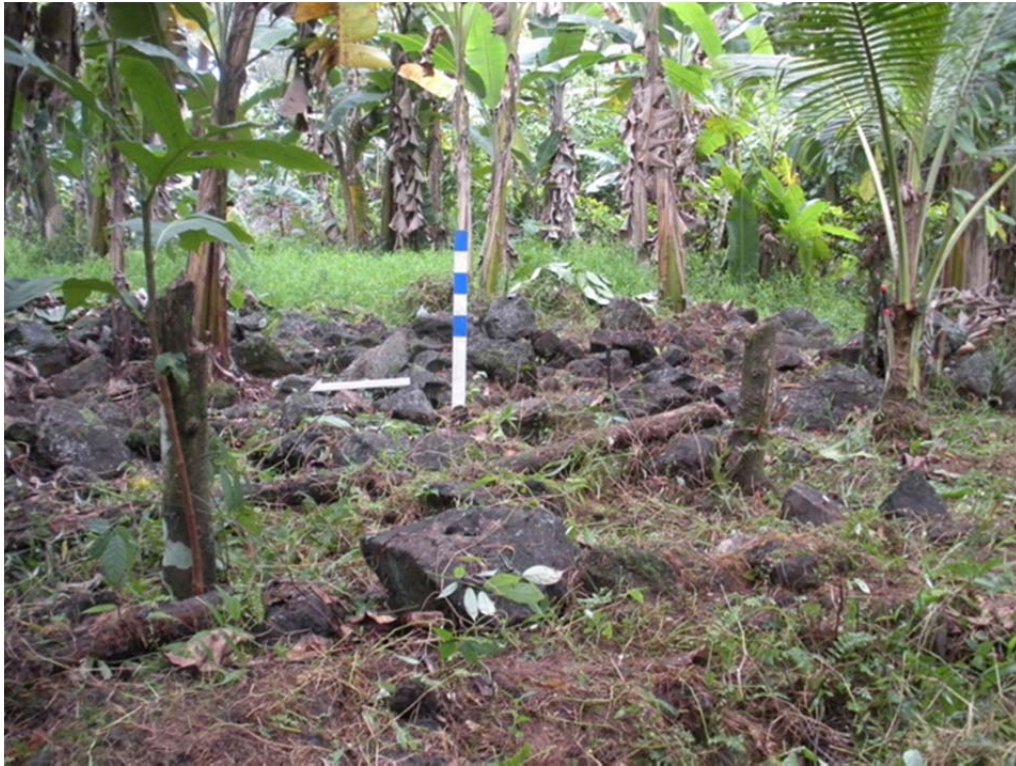
Figure IV-13. The central area of Feature 1, Site PoC3-44.

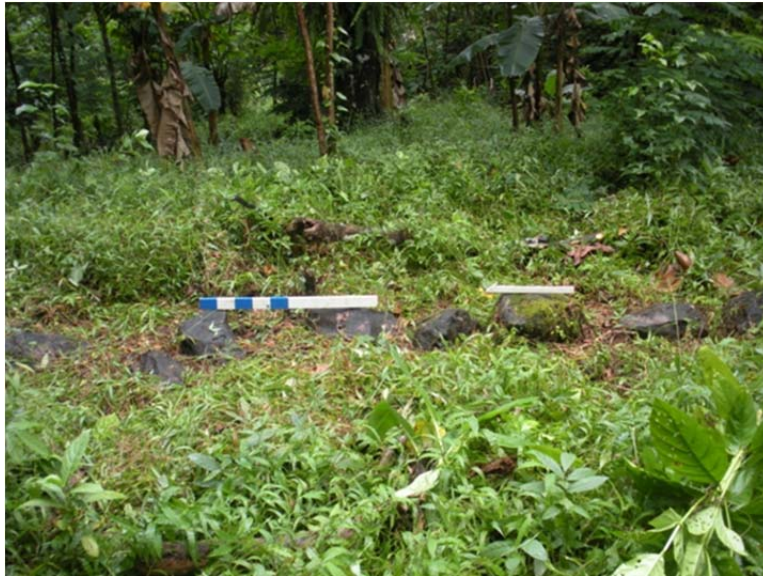
Figure IV-14. Site PoC3-46, Feature 2, central area.

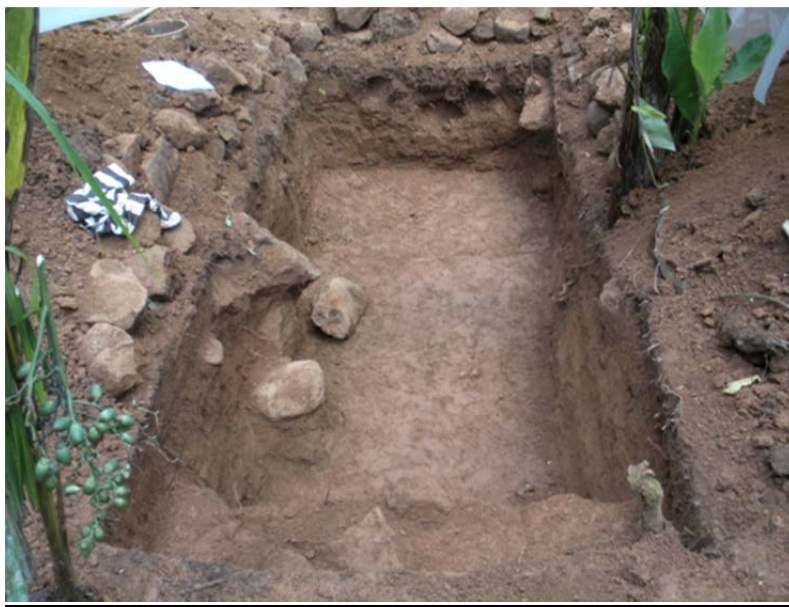
Figure IV-19. PoC3-18 Trench

This excavation unit contained multiple alignments of basalt cobbles. The 50-60cm level served as the base for alignments of cobbles near the southeast, southwest, and northeast corners. As the basalt cobbles in these alignments all rested on the same surface and did not seem to be distributed randomly throughout the deposit, it is likely that their placement was deliberate. It should also be noted that the ground surface in the low point of the pit was at 48cm, so the top of some of the cobbles at the north end was visible pre-excavation. However, they were resting on the same surface as the definitively covered cobbles at the south end of the

deposit. In the northeast corner are two layers of cobbles, one with a surface in the 90-100cm level, and one with a surface in the 100-100cm level; they appear to have been stacked on top of each other. If this pit was used for breadfruit fermentation, the placement of the cobbles seems to follow logically, as the organic material in the fermentation pit is typically covered with stones and sediment (Balick 2009). This seems to suggest that the pit may have been used for breadfruit fermentation. However, it should be noted, that based on the stratigraphy of other breadfruit pits on Temwen (see PoC3-12, F2 and PoC3-50, F2 in this report; also Ayres et al. 2009) and elsewhere on Pohnpei (Haun 1984), the sediment layers appear atypical. However, the changes in sediment layers in breadfruit pits on Temwen tend to be subtle, so breadfruit fermentation cannot be ruled out based on this alone.

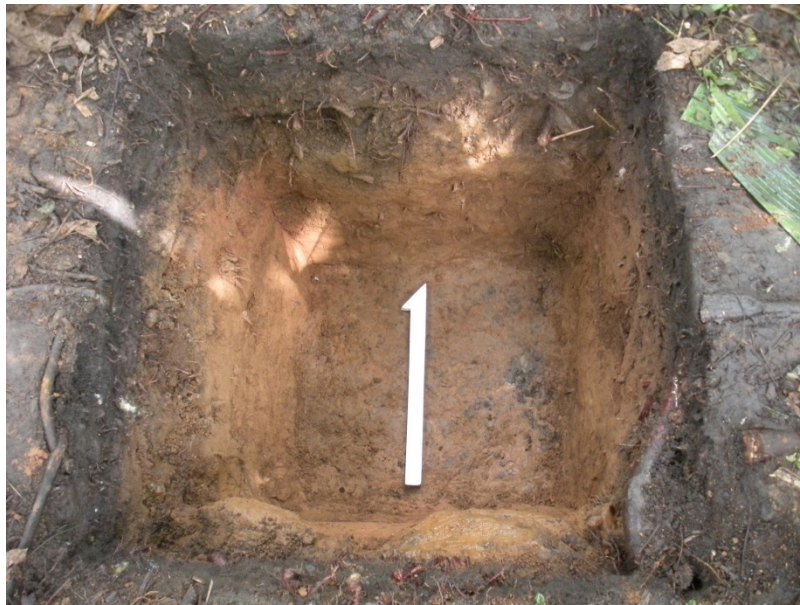
Figure IV-24. PoC3-12, Feature 4. Post-excavation.

This excavation unit contained all of the artifactual material recovered during this project. Artifacts recovered include eleven nails (Fig. IV-25), four linoleum tile fragments, three plastic container fragments, two glass fragments, one cloth fragment, and one piece of metal. Artifacts were recovered from the top 30cm using

a screen and by hand. It is likely, given the contents of this assemblage, that this area was used for cooking exclusively during the historic period. There was also one small-medium mammal bone recovered, which is likely either dog or pig. The vast majority of cultural material recovered from the top 30cm, however, was charcoal, which was very thick in Layer I.

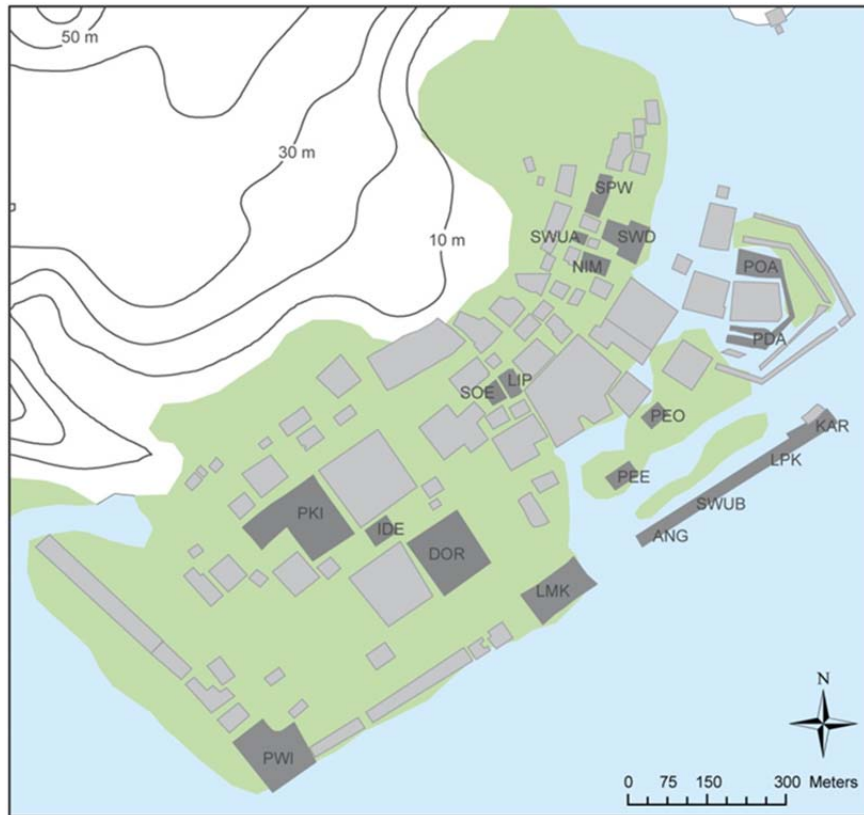
Figure V-1. Distribution of islets field checked in this project at Nan Madol.

The following islets were chosen for the status survey because of the detailed maps already produced, their variable sizes and ages, and their wide distribution across the site, including the Nan Madol Powe and Pah sections. Although time did

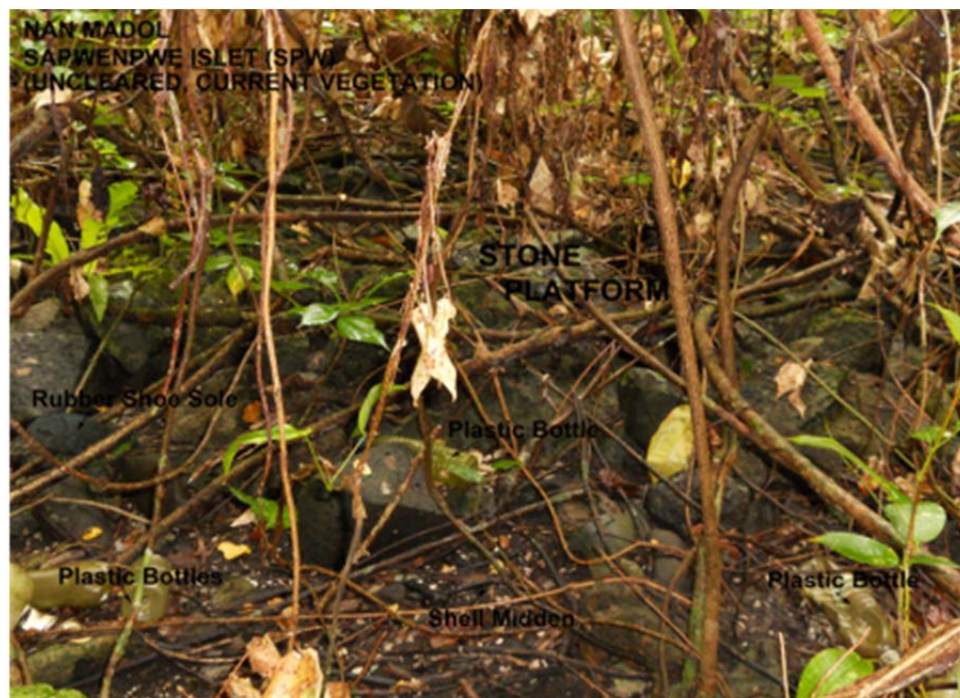
Figure V-2. Detail of the state of Sapwenpwe Islet, Nan Madol (PoC3-1-SPW), showing present-day vegetation (uncleared), a stone platform (Fea. 15), and selected surface artifacts and occupational refuse. Historic artifacts shown are tidal float residue. [image: K. Seikel]

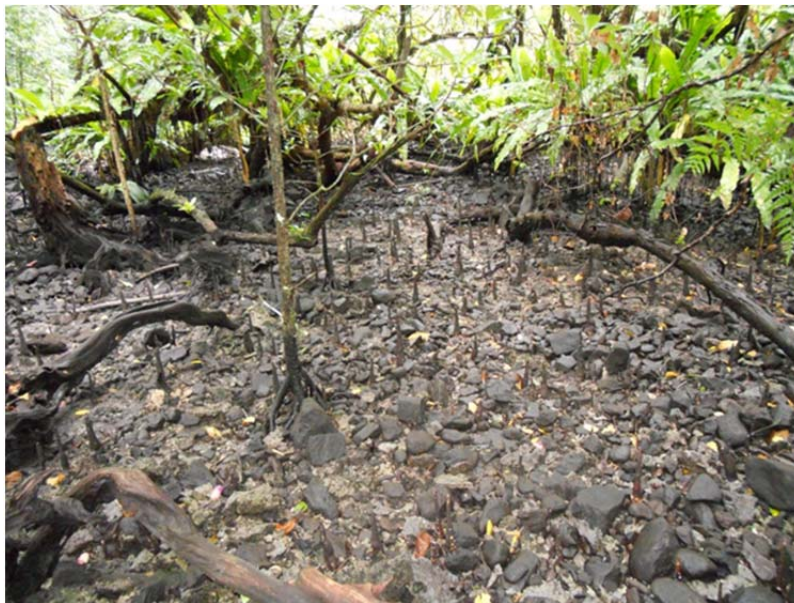
Figure V-3. Mangroves encroaching on Nihmokemok Islet (PoC3-1-NIM). The surface is deflated by tidal action.

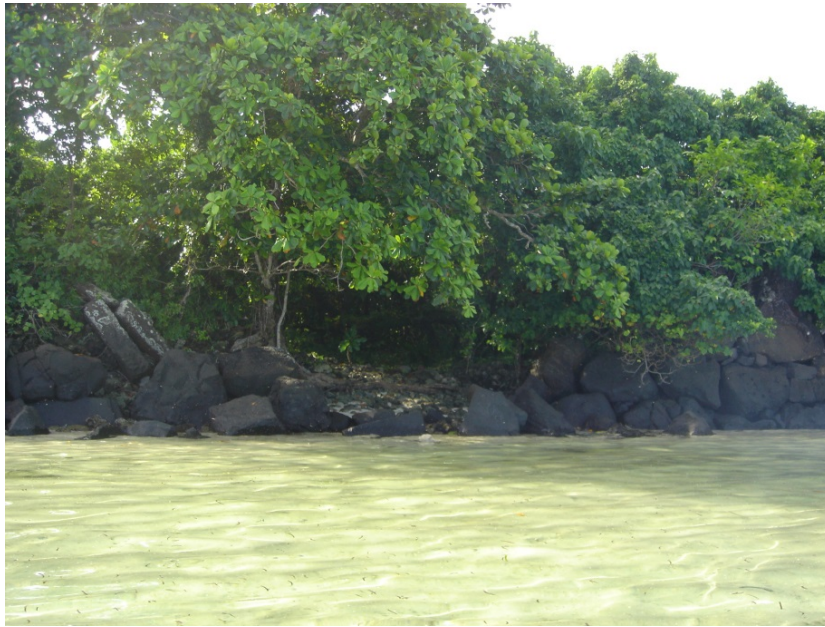
Figure V-4. A disturbed area along E seawall of Nan Madol (Angeir-Sapwuhtik B) This reflects a combination of wave damage, remodeling, and settling of architectural fill.

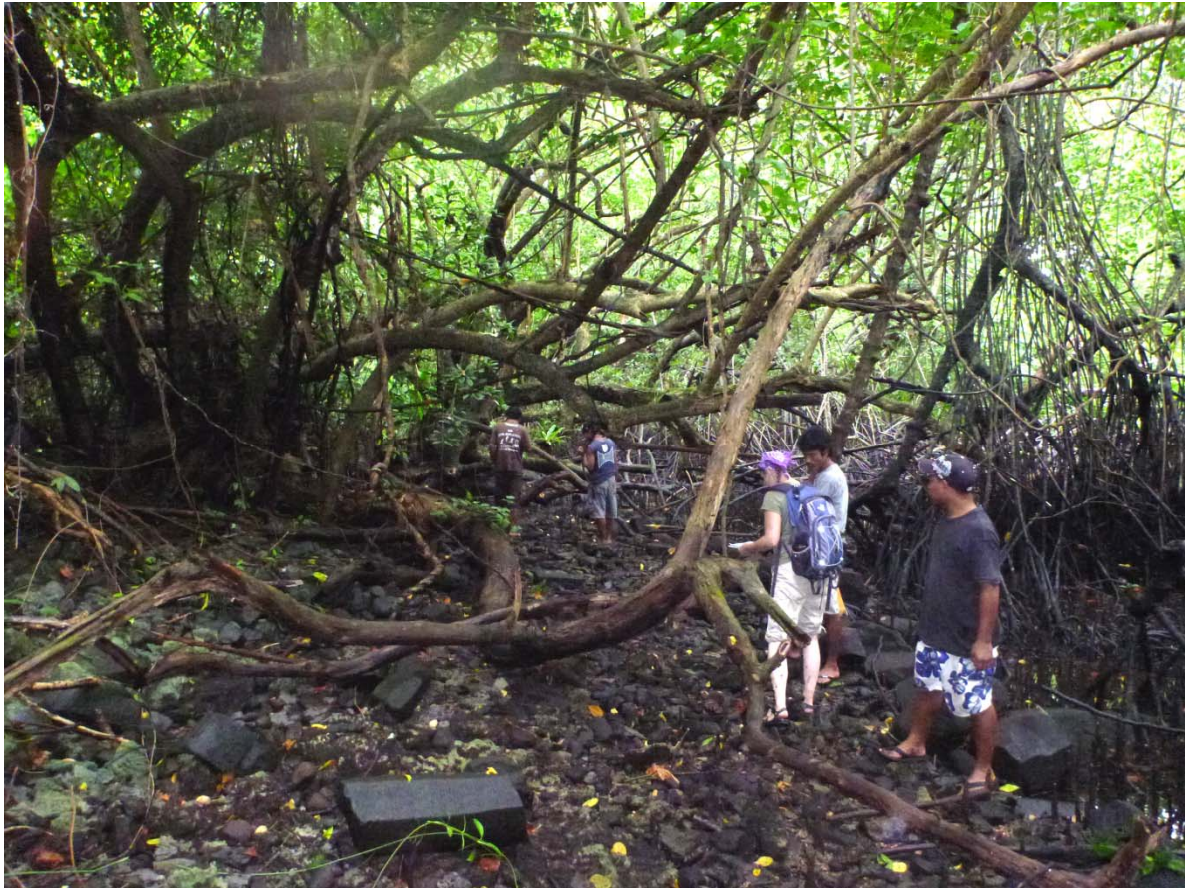
Figure V-5. Katherine Seikel and co-workers examine an interior Nan Madol islet surface showing sediment deflation due to tidal flooding and mangrove incursion into the surrounding canals. The islet surface at the edges is at or near the level of tidal muds. [photo: A. Craib].

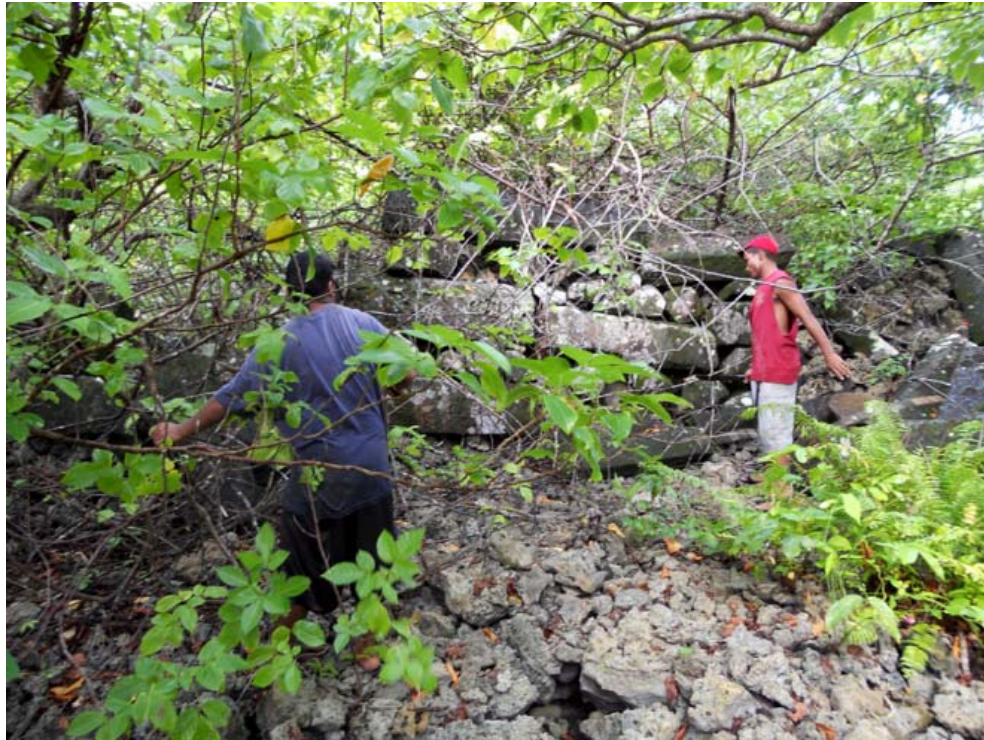
Figure V-6. View of seawall structural remains and existing strand vegetation, Site PoC3-1, Nan Madol. [image: K. Seikel].

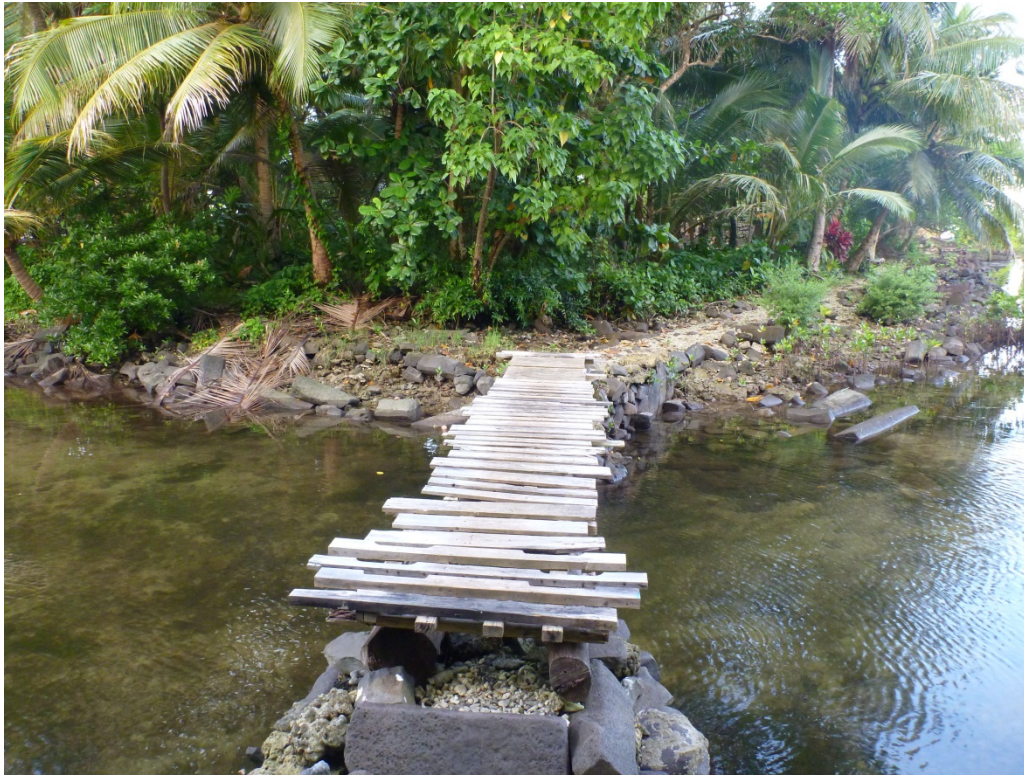
Figure V-7. Site PoC3-1, Nan Madol. Tourist walkway bridge between Usendau and Dau Islets. [image: Alex Craib].

walkway (Fig. V-7). The tourist walkway is constructed from material taken from the site itself. There are few surface remains alongside the walkway in most areas, which may be a combination of the walkway construction and curio hunting by visitors. Often, areas a short distance from the walkway still have preserved surface remains. At present, there is no signage at the site stating that it is a protected site. Aside from the walkway related issues, other human impacts at Nan Madol are uncontrolled surface collecting of artifacts, unauthorized digging, structural collapse from visitors walking on fragile stone works, and activities related to subsistence practices. A few local families have breadfruit and coconut trees planted on certain islets; these are linked to family use-leases issued during the German administration of Pohnpei. These tree plantings in some cases have had a significant impact on stone architecture and the root systems of coconut palms have a different impact than other kinds of trees. On the other hand, these were mostly planted some time ago and many other trees and shrubs grew up naturally. A detailed assessment of vegetation impacts on the site should be undertaken. On the seawall there is evidence of coral rubble being moved to build fires to cook fish, and in some locations the grilling grates and some trash have been left behind. Sand is also being mined from the reef flats and beaches adjacent to the seawall islets.
